| | REVISIONS | | |
|---|--|---|---|
| 1 | Initial Report Based on Field Measurements Taken | July 2, 2015 | RW |

1 Summary

2 Review of Findings, Conclusions and Remedial Actions

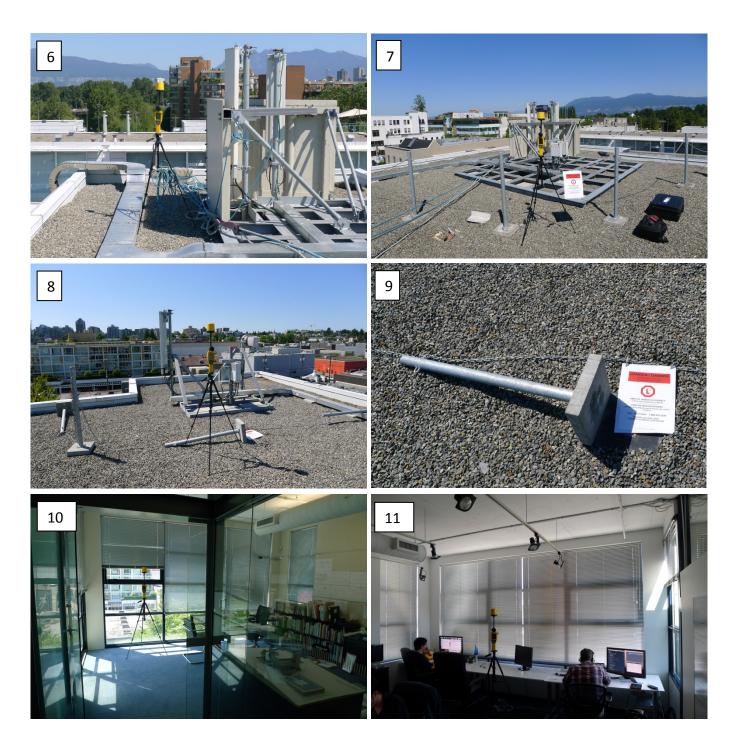
Photograph Legend

- 6- Spatial Average Test Location In front of antenna inside restricted area on north end of the roof.
- 7- Spatial Average Test Location North end of roof outside of restricted area.
- 8- Spatial Average Test Location South end of roof outside of restricted area.
- 9- Fence-post and RF Energy Danger demarcation sign that are normally upright, but were down for window washing.
- 10- Spatial Average Test Location South Office
- 11- Spatial Average Test Location North Office

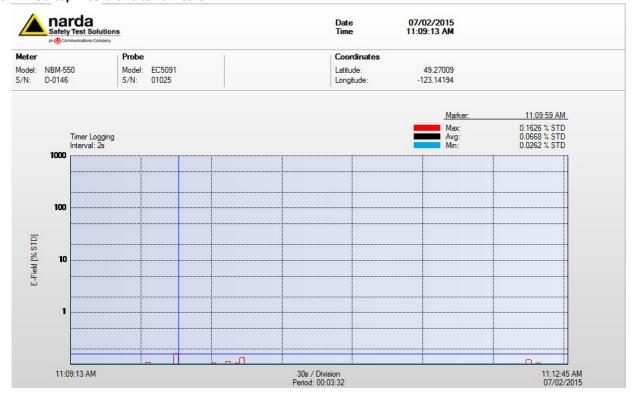
6.3.1 Rooftop - Cellular Site Turned OFF

The maximum, instantaneous measured value measured on the roof of the building was:

- 1.7723% of the 2015 Uncontrolled Limit with the cell-site turned off,
- 7.4338% of the 2015 Uncontrolled Limit with the cell-site turned on outside of the restricted area, and
- 368.09% of the 2015 Uncontrolled Limit with the cell-site turned on inside the restricted area.

The following graphs show minimum, maximum, and average power density values measured across the administration building upper floor and rooftop. It is noted that the Narda NBM550 measures percentage of Safety Code 6 (2009) limit for Controlled Environments. Measurements can be multiplied by the factors discussed above to determine percentage of Safety Code 6 (2015) limit for Uncontrolled Environments.

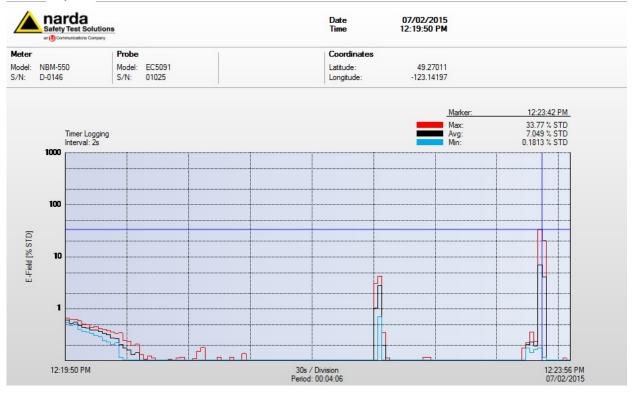
6.3.2 Rooftop - Cellular Site Turned ON

The values recorded that exceed 1% were measured inside the restricted areas of the roof in front of the antennas.

No remedial action is required – the site is compliant to Health Canada Safety Code 6 (2015). The appropriate action has been taken to restrict access to the areas that exceed Safety Code 6 Limits for Uncontrolled Environments by chaining off the area and putting up appropriate demarcation signs.

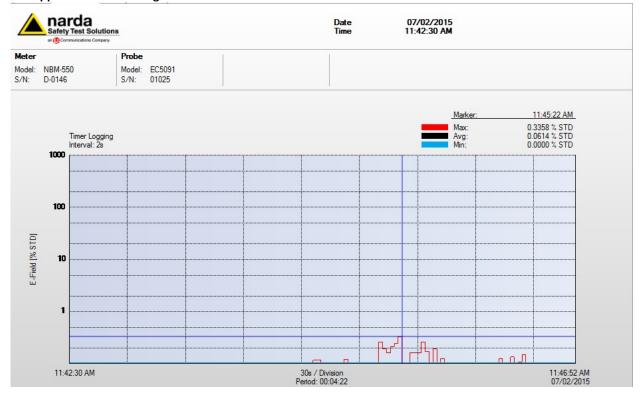
6.3.3 Upper Floor of Building – Cellular Site Turned OFF

The maximum, instantaneous measured value measured on the upper floor of the building was:

- 3.6602% of the 2015 Uncontrolled Limit with the cell-site turned off, and
- 2.0307% of the 2015 Uncontrolled Limit with the cell-site turned on.
